CBC Aids WVDEP with Fresh Water Reservoir - Chief Logan State Park

Authorization to proceed with the evaluation of the Chief Logan dam was given in a letter from Dr. Eli Laidley McCoy, Director, WV Division of Environmental Protection, dated January 29, 1997. At the time the Chief Logan embankment was zoned a dam consisting of a central clay core with upstream and downstream miscellaneous soil and rockfill shells. The crest elevation of the embankment is 886 feet, the overall height of the embankment is 58 feet from the upstream toe to the crest, and the normal pool elevation is 870 feet. The embankment was constructed during June, 1995, through December, 1995. CBC was hired to find out why the dam was not holding water creating the desired fresh water reservoir.

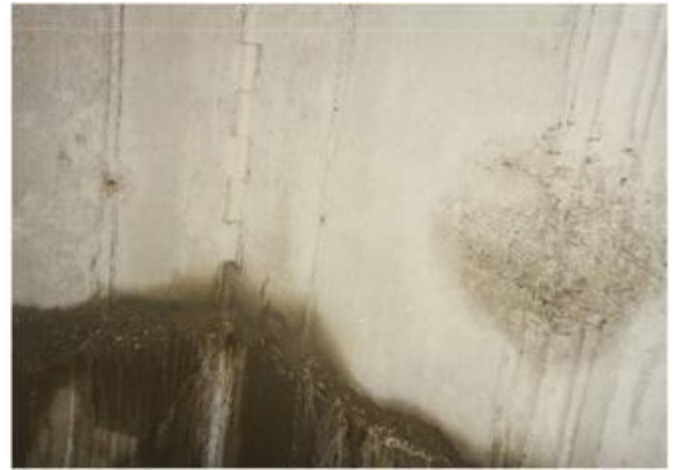
The reinforced-concrete intake structure was visually examined by CBC Engineers and Associates, Ltd., personnel on June 3, 1997, with the assistance of L.J. Hughes and Sons personnel. The intake structure was accessed via a small row-boat provided by the Chief Logan Ranger's office. Upon entry into the interior of the structure through the top of the structure. The interior walls were noted to be wet below the level of the pool, and are apparently stained with iron oxide (Photograph to the right). It was also noticed throughout the interior of the chamber that there are numerous zones of "honeycombed" concrete, some of which have apparently been patched. Also revealed by our visual examination is the presence of apparent "cold-joints" that are now leaking water into the chamber from the pool. The amount of flow through the cold-joint appears to be significant, based on the magnitude of the staining on the interior chamber walls. Zones of efflorescence were also noted along the apparent cold-joints. There is also a significant concentration of relatively large shrinkage cracks in the concrete walls.

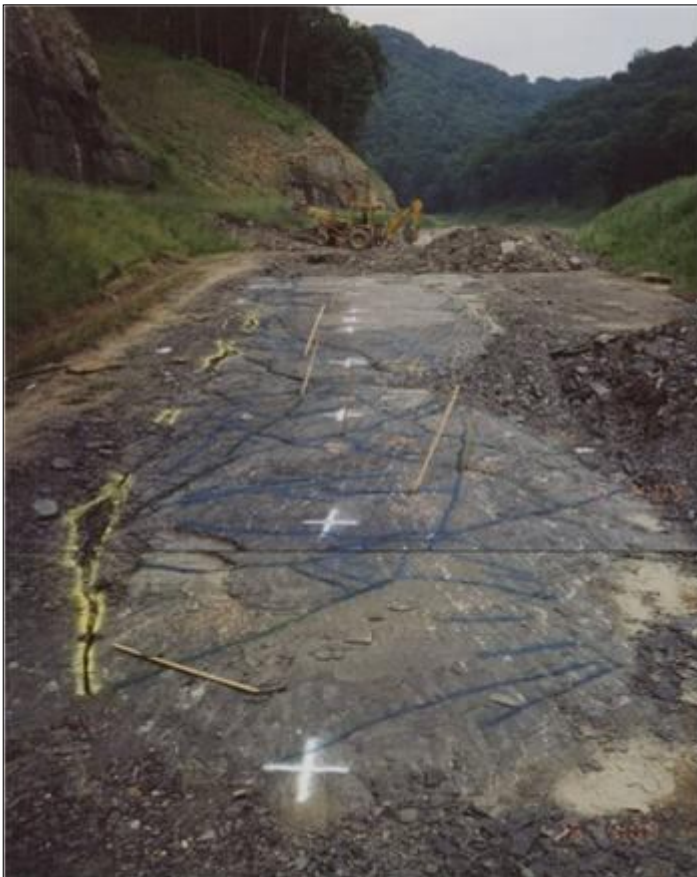
could be due to the lack of a watertight seal of the gate valve. An area of the spillway was cleared off by Marcum Excavating to determine the nature of the blast-induced crack pattern in the bedrock in the spillway. A relatively large area was excavated to bedrock (Photograph to Left). Once the area near the centerline of the embankment was reached, the depth to bedrock increased. A test trench was excavated to the edge of the upstream bench. Bedrock in this area was found to extend to depths up to 10 feet beneath the existing site grade. A profile of the rock near the dam side of the spillway is shown in Figure 4-10. The actual rock line is plotted versus the original spillway plan elevation. From about the downstream edge of the crest of the dam trending upstream the rock apparently had been overshot by blasting or was at greater depths than the bottom of the spillway. The backhoe excavated a trench into the berm between the spillway and the dam. It was found that this berm was fill and not rock (Photograph 4-21). Photographs 4-22 through 4-24 show the excavation and the fill which had been placed in the spillway in this area. An area downstream of the crest of the embankment also contained fill material in which bedrock had apparently been overshot and a crater had been created. The entire area excavated by the backhoe was washed with high pressure hose utilizing the

drill rig pumping equipment to expose the crack pattern for geologic mapping.

A grid pattern was then established by the CBC Engineer's geologist with white paint; cracks greater than 1 inch wide were marked yellow, cracks that measured 1/8 inch to 1 inch were marked green, and cracks less than 1/8 in width were marked blue for photographic purposes. The Photograph to the Left shows the marked cracks in the spillway. Photographs were also taken of the cracks during surveying activities used to map the crack pattern in the bedrock. It was relatively obvious from the profile, as well as the cross-sections of the spillway after excavating to bedrock, that a considerable amount of fill has been placed in the spillway, and that bedrock was not present at the flow depth of the spillway over a relatively large portion of the spillway. Cross-sections across the excavated area in the spillway (which were taken on 10 foot centers through the area excavated), and a profile in three different locations down the spillway were developed to illustrate the location of rock in the spillway. .

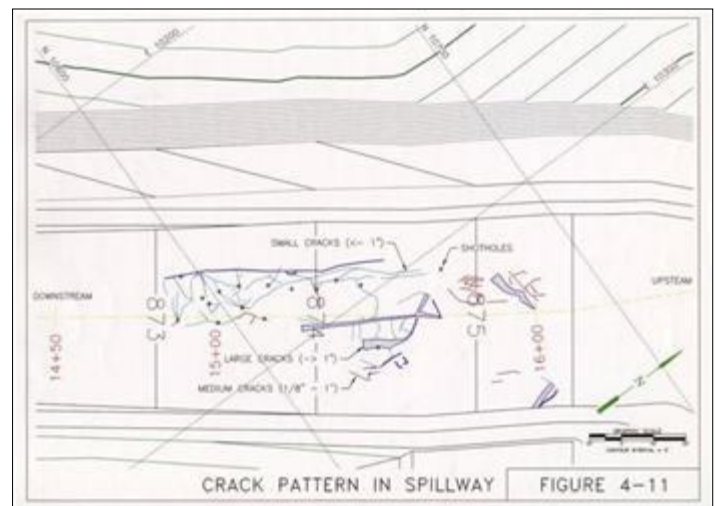
A relatively large portion of the spillway in the area of the crest of the embankment is not constructed in sound rock. Some considerable portion of the spillway bottom and the side slope adjacent to the dam consists of fill which was placed in these areas due to either the lack of bedrock in this locale, or due to the effects of overblasting the rock. If this area is simply refilled with earthen material it could erode out during a storm event. The velocities in this portion of the spillway during a PMP event are about 17 feet per second. This velocity is sufficient to erode out the earthen fill if it were not replaced. Also, the material as it currently exists does not appear to have been compacted. There are no records of compaction tests in any of the old fill that exists in the spillway. Observations performed during the excavation of the spillway indicate that there are large rock fragments and stones placed in the spillway area, which would not have permitted proper compaction even if compaction had been attempted during the original construction of the dam. This material in the spillway is composed of rocks of varying size, with a matrix of clays, and silts. This fine grained matrix will be highly erodable, and in our opinion would erode out during high storm flows through the spillway. In addition, the highly cracked nature of the spillway bottom would allow considerable flow of water into the embankment during storm flows, potentially creating a problem with erosion and/or piping of the embankment proper. For these reasons, the spillway should be repaired.

Based on our evaluation, it is recommended that the following methodology of repair be accomplished. The old fill material in the spillway in the location shown on Figure 9-6 should be removed down to solid rock all the way across the cross-section of the spillway. Dental concrete should then be used to fill any cracks and crevasses within the exposed rock surface. After the fill is removed, a high pressure hose should be used to wash down the rock and wash out any soil within cracks, and the dental concrete should be used to fill cracks and crevasses within the fractured rock mass of the spillway. Once this was accomplished, compacted fill that was compacted to a dry unit weight equal to at least 95% of the maximum dry unit weight as achieved by the standard Proctor test was brought back to a grade that was approximately 4 inches below the design finished grade of the spillway. Once the spillway area was filled to within 4 inches of grade, a reinforced concrete protective liner was to be placed. The reinforced concrete liner must measure at least 4 inches in thickness, and be properly reinforced. This extended over the entire bottom section of the spillway in the zone shown below. The liner was to be keyed into the undisturbed rock on the upstream edge to prevent piping of water beneath the liner. The side of the spillway adjacent to the dam is fill and was to be protected with grouted riprap.
