CBC Visits Big Sky Country to Aid Montana DOT with Buried Flexible Bridge / Culvert Program

Federal Aid Project IM 94-4(76)119 – Under Interstate I-94 (Site 7- Mile Post 167.1) Prarie County, Montana

Federal Aid Project IM 94-4(76)119 – Under Interstate I-94 (Site 6- Mile Post 147.4) Custer County, Montana

Federal Aid Project IM 94-4(76)119 – Under Interstate I-94 (Site 8- Mile Post 197) Dawson County, Montana

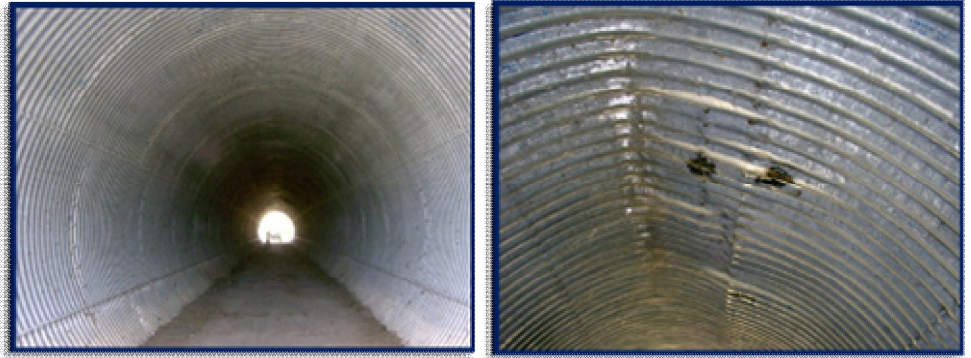
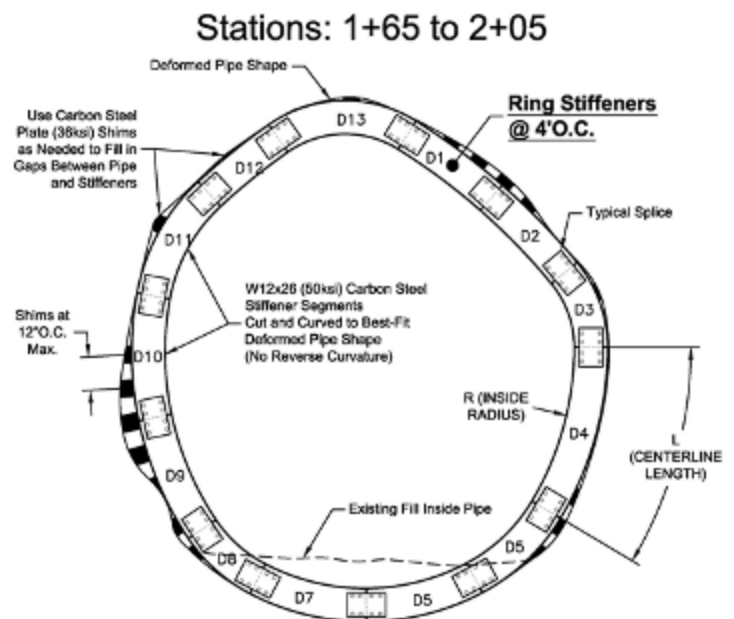
Evaluation Results:
Generally Fair Condition

The maximum deflection of any top mid-ordinate was 26.6%. Based on the MULT-SPAN program recommendations no remedial action due to shape was recommended for the structure. However MULT-SPAN did recommend reducing the legal load to 75%. CBC Engineers and Associates, however, did not believe this necessary because of the length of time the structure has been in place and the likely hood that deflection has ceased. It was recommended to monitor the structure again in 6 months to a year due to the mid-ordinates approaching critical magnitudes. Based on the rating of the structure, the structure has 33 points out of a possible 42. This rating is an equivalent to a 5 on the National Bridge Rating System. Plastic hinging of the structure had occurred in the top of the structure from Station 1+74 to 1+85 and remedial action was required in this area. The stiffeners used to repair the hinging were comprised of segments of wide flange beams cut and curved to best fit the in-situ shape of the

Remediation Solution:
Plastic Hinging from Station 1+74 to 1+85 were required Ring Beam stiffeners to carry load. These stiffeners were used from Station 1+65 to 2+05 well past the affected areas.

The segments of beam were spliced together at their ends to form a continuous ring stiffener around the entire periphery of the structures. All stiffeners were Grade 50 steel and hot-dipped galvanized. Any gaps between the ring stiffeners and the pipe walls were filled with galvanized steel plate shims as shown on the drawing (to right) to provide consistent contact between the stiffener and the pipe. The required size and spacing of the stiffeners was determined using SSTAN finite element structural analysis software developed by Dr. Marc Hoit of the University of Florida.

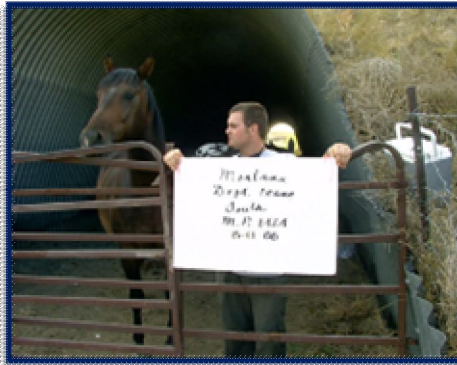
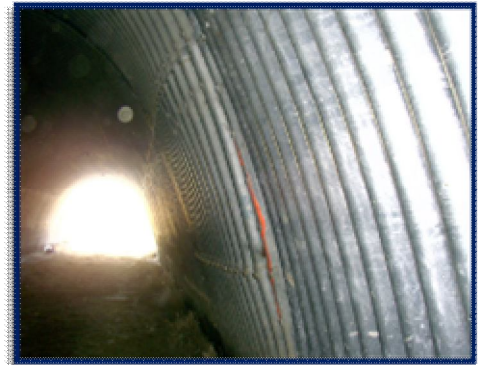
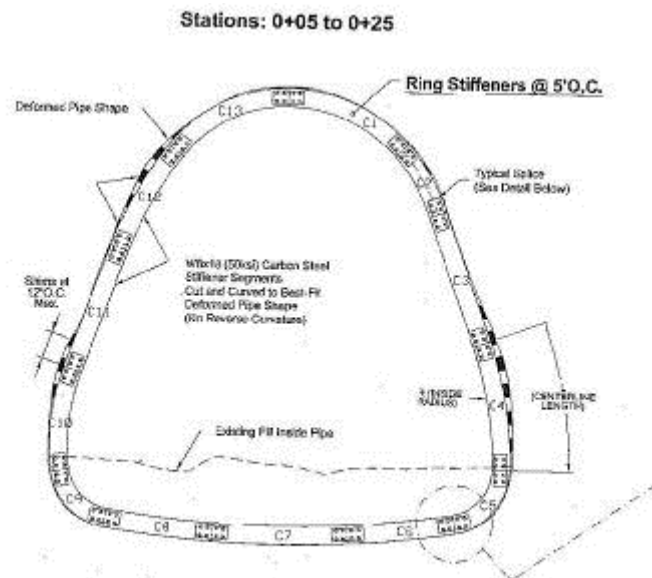
Evaluation Results:
Generally Fair Condition

The maximum deflection of any top mid-ordinate was 26.6%. Based on the MULT-SPAN program recommendations no remedial action due to shape was recommended for the structure. However MULT-SPAN did recommend reducing the legal load to 75%. CBC Engineers and Associates, however, did not believe this necessary because of the length of time the structure has been in place and the likely hood that deflection has ceased. It was recommended to monitor the structure again in 6 months to a year due to the mid-ordinates approaching critical magnitudes. Based on the rating of the structure, the structure has 33 points out of a possible 42. This rating is an equivalent to a 5 on the National Bridge Rating System. Plastic hinging of the structure had occurred in the top of the structure from Station 1+74 to 1+85 and remedial action was required in this area. The stiffeners used to repair the hinging were comprised of segments of wide flange beams cut and curved to best fit the in-situ shape of the

Remediation Solution:
Plastic Hinging from Station 1+74 to 1+85 were required Ring Beam stiffeners to carry load. These stiffeners were used from Station 1+65 to 2+05 well past the affected areas.

structures as shown on the drawings attached to this report. The segments of beam were spliced together at their ends to form a continuous ring stiffener around the entire periphery of the structures. All stiffeners were Grade 50 steel and hot-dipped galvanized. Any gaps between the ring stiffeners and the pipe walls were filled with galvanized steel plate shims as shown on the drawing (to right) to provide consistent contact between the stiffener and the pipe. The required size and spacing of the stiffeners was determined using SSTAN finite element structural analysis software developed by Dr. Marc Hoyt of the University of Florida.

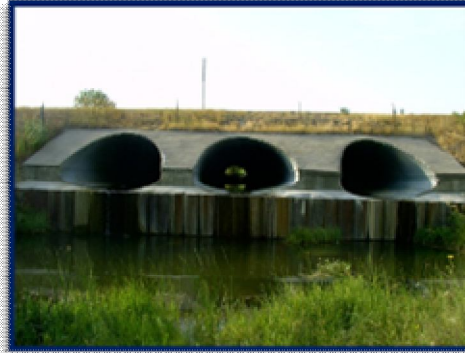
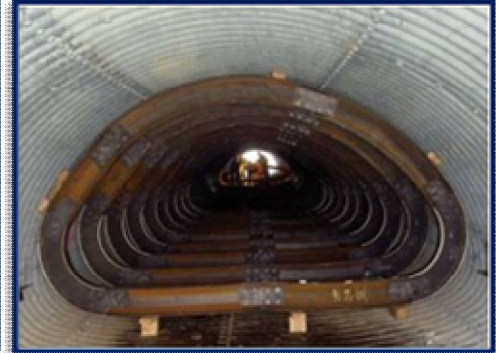
Evaluation Results:
West Structure – Marginal Condition
Middle Structure – Poor Condition
East Structure – Poor Condition

These three Multi-Plate Pipe Arches upon field inspection showed various distresses from invert corrosion, poor shape geometry, bolt hole tearing, to raised invert plates with voids below in the structures bedding. The ratings for these structures were 29 (West Structure), 21 (Middle Structure) and 25 (East Structure). These culvert ratings equate to 4, 3 and 3 respectively on the National Bridge Inspection rating system. The West Structure rating was controlled by poor corrosion in the invert and the Middle and East Structure ratings were controlled by both poor shape geometry and same rust in the invert. This site was one of 9 total culvert rehabilitation sites let by Montana Department of Transportation as a result of CBC Engineers and Associates inspection, evaluation and remediation designs. These repairs were let by the State of Montana in 2008. A computer program (MULTSPAN) developed under contract to FHWA and the State of Ohio DOT was used to evaluate the shortening of mid-

The MULTSPAN analysis provides recommendations for remedial action on the basis of the degree of flatness of top arcs within the structure. The ratings above as well as the remedial action taken came straight from the field measurements made by CBC Engineers and Associates and the output of the MULTSPAN program. From here The Montana Department of Transportation asked CBC Engineers and Associates for actual field repairs that would extend the lives of these structures in place without replacement.

Remediation Solution:
West Structure – New Concrete Paved Invert
Middle and East Structures – New Ring Beam Stiffeners & Concrete Paved Invert

In order to repair these structures in place, CBC Engineers and Associates designed the following. First the West Structure had significant rust in the bottom flowline area. The most practical solution to this rust was to concrete pave the flowline area with concrete. The Middle and East Structures required much more attention. In addition to requiring ring stiffeners at selected areas, these two structures had tears around the bolt holes, raised invert plates and significant invert corrosion. The bolt hole tears should be repaired by filling the tears with E70XX weld to completely fill the tears then coating the welded areas with 2 coats of Galvanox or other zinc-rich coating in accordance with the manufacturer's procedures. The invert repairs of the West Structure were then used as well once all new stiffeners were installed.
