CBC Aids WVDEP with Fresh Water Reservoir - Chief Logan State Park

Authorization to proceed with the evaluation of the Chief Logan dam was given in a letter from Dr. Eli Laidley McCoy, Director, WV Division of Environmental Protection, dated January 29, 1997. At the time the Chief Logan embankment was zoned a dam consisting of a central clay core with upstream and downstream miscellaneous soil and rockfill shells. The crest elevation of the embankment is 886 feet, the overall height of the embankment is 58 feet from the upstream toe to the crest, and the normal pool elevation is 870 feet. The embankment was constructed during June, 1995, through December, 1995. CBC was hired to find out why the dam was not holding water creating the desired fresh water reservoir.

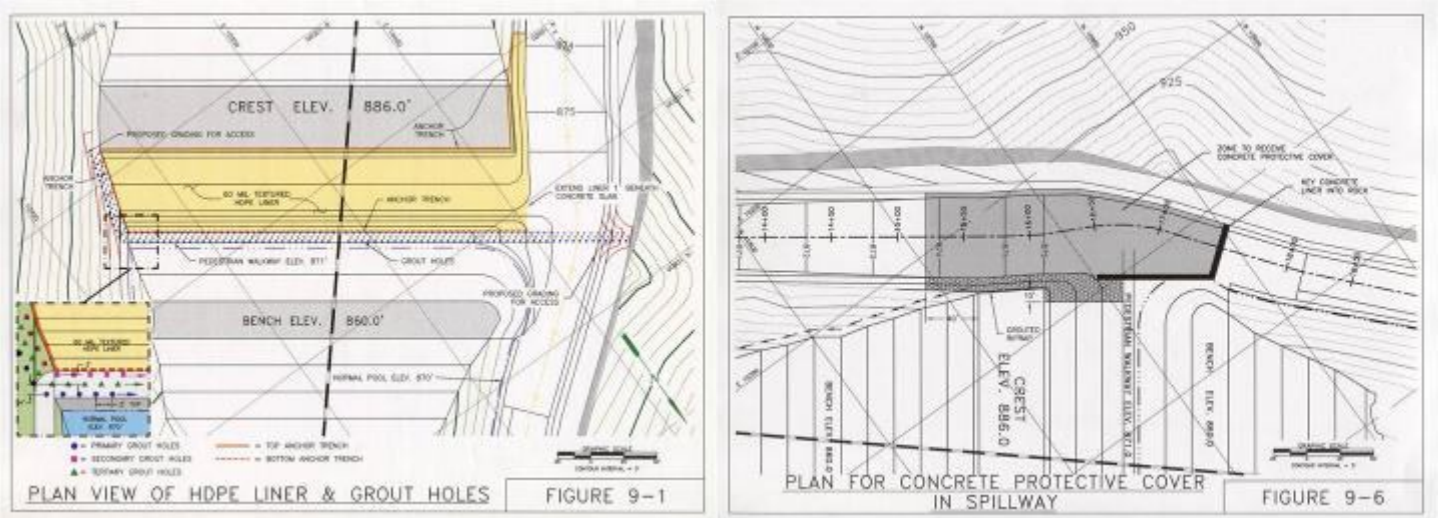
A relatively large portion of the spillway in the area of the crest of the embankment is not constructed in sound rock. Some considerable portion of the spillway bottom and the side slope adjacent to the dam consists of fill which was placed in these areas due to either the lack of bedrock in this locale, or due to the effects of overblasting the rock. If this area is simply refilled with earthen material it could erode out during a storm event. The velocities in this portion of the spillway during a PMP event are about 17 feet per second. This velocity is sufficient to erode out the earthen fill if it were not replaced. Also, the material as it currently exists does not appear to have been compacted. There are no records of compaction tests in any of the old fill that exists in the spillway. Observations performed during the excavation of the spillway indicate that there are large rock fragments and stones placed in the spillway area, which would not have permitted proper compaction even if compaction had been attempted during the original construction of the dam. This material in the spillway is composed of rocks of varying size, with a matrix of clays, and silts. This fine grained matrix will be highly erodable, and in our opinion would erode out during high storm flows through the spillway. In addition, the highly cracked nature of the spillway bottom would allow considerable flow of water into the embankment during storm flows, potentially creating a problem with erosion and/or piping of the embankment proper. For these reasons, the spillway should be repaired.

Based on our evaluation, it is recommended that the following methodology of repair be accomplished. The old fill material in the spillway in the location shown on Figure 9-6 should be removed down to solid rock all the way across the cross-section of the spillway. Dental concrete should then be used to fill any cracks and crevasses within the exposed rock surface. After the fill is removed, a high pressure hose should be used to wash down the rock and wash out any soil within cracks, and the dental concrete should be used to fill cracks and crevasses within the fractured rock mass of the spillway. Once this was accomplished, compacted fill that was compacted to a dry unit weight equal to at least 95% of the maximum dry unit weight as achieved by the standard Proctor test was brought back to a grade that was approximately 4 inches below the design finished grade of the spillway. Once the spillway area was filled to within 4 inches of grade, a reinforced concrete protective liner was to be placed. The reinforced concrete liner must measure at least 4 inches in thickness, and be properly reinforced. This extended over the entire bottom section of the spillway in the zone shown below. The liner was to be keyed into the undisturbed rock on the upstream edge to prevent piping of water beneath the liner. The side of the spillway adjacent to the dam is fill and was to be protected with grouted riprap.
